Heat-induced drill pipe failures

Rotating while packed off may cause unexpected heat-induced drill pipe tensile failures

Samit Gokhale and Sean Ellis, T H Hill Associates, Inc.; Nicholas Reynolds, SPE

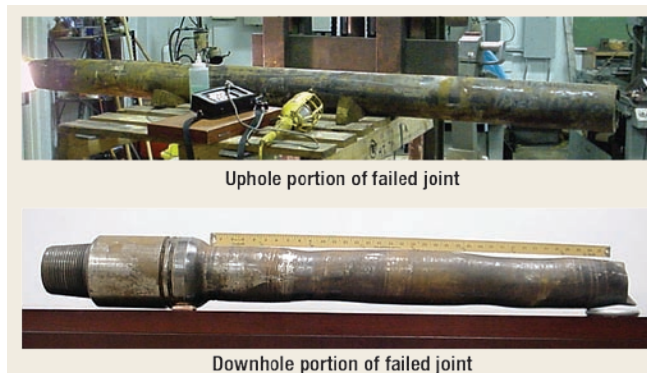
Visual examination. The overall appearance and fracture morphology of joints C1 and C2 were strikingly similar. Both failures were located in drill pipe tube body, close to the pin connection tool joint. Joint C1 had parted 3 ft 11 in. from the pin connection shoulder, while joint C2 had parted 6 ft 5 in. from the pin connection shoulder. The fractured joints are presented in Figs. 1 and 2.

Fig. 1. As received condition of the failed 5-in. 19.50-lb G-105 drill pipe C1.

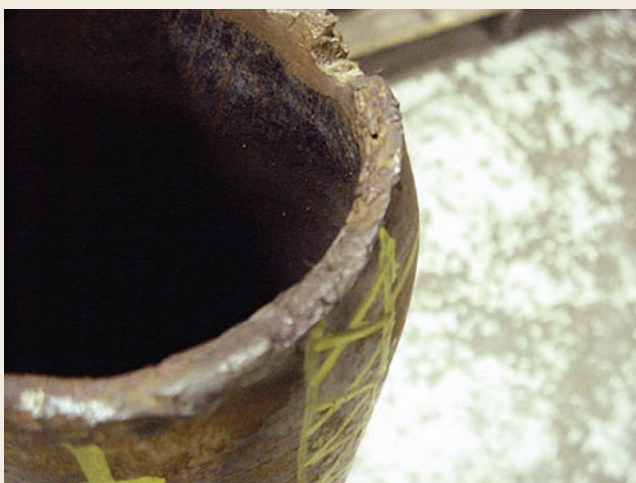
The fracture surfaces displayed evidence of a ductile separation under tensile loading. As shown in Fig. 3, the fractures propagated along a 45° plane relative to the axis of the pipe. The fracture regions also exhibited significant necking and extensive plastic

Fig. 3. 45° fracture surface of joint C2.

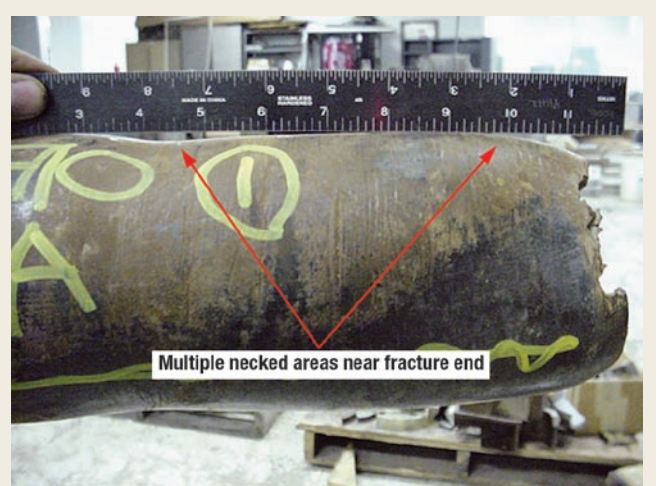
deformation. However, the necking was different from that observed on classic ductile overload failures. Joints C1 and C2 presented multiple closely spaced necked areas near the fractured ends. Figure 4 presents the necking and the plastic deformation. Overall, the fracture morphology was indicative of a ductile tensile overload.

Fig. 4. Necking and plastic deformation observed near the fractured end of joint C2.

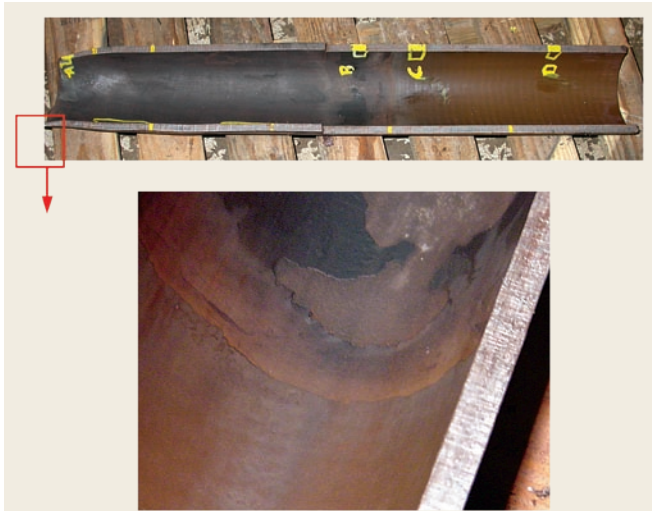
To evaluate the internal surface, the fractured joints were saw-cut longitudinally and split open. Figure 5 presents the condition of joint C1’s internal coating. The internal plastic coating was damaged close to the fractured end. The color and texture of the internal plastic coating also changed towards the fractured end. The damage appeared to have been caused by exposure to unusually high operating temperatures.

Fig. 5. Damage to internal plastic coating of joint C1 from exposure to high temperatures.

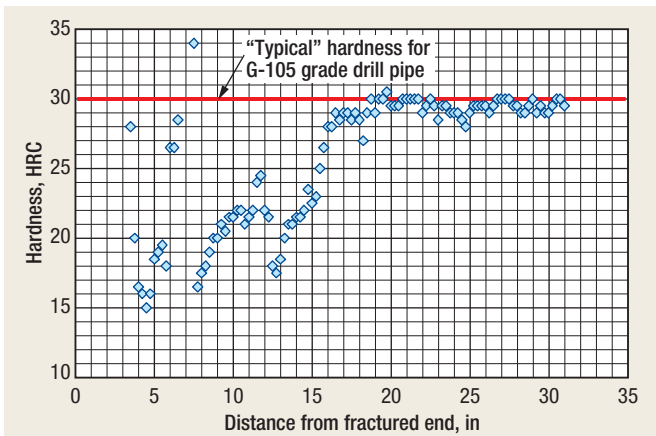
For joint C1 (G-105 drill pipe, typical Rockwell “C” hardness = 30 HRC), the average hardness reading outside the heat affected area was about 30 HRC. This hardness correlates to a tensile strength of about 136,000 psi. However, a drop in hardness to values as low as 15 HRC, which correlates to a tensile strength of about 100,000 psi, was observed near the fracture.

Fig. 6. Hardness (HRC) readings along the length of longitudinal section removed from joint C1.

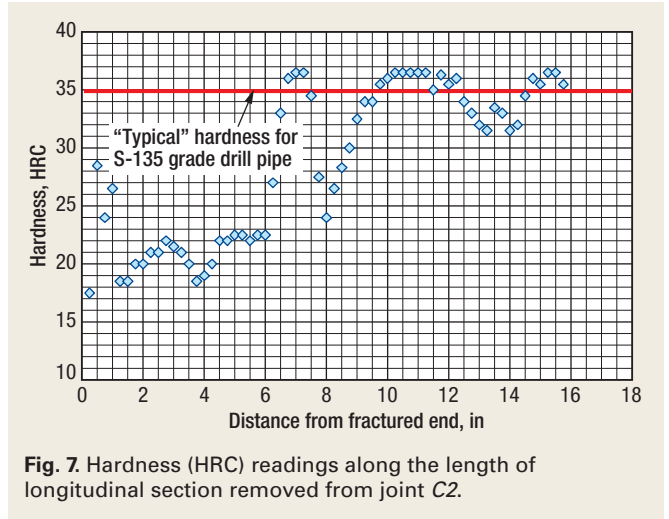
Similar to joint C1, a drop in hardness close to the fracture was observed on joint C2 (S-135 drill pipe, typical Rockwell “C” hardness = 35 HRC). The hardness values reduced from an average close to 35 HRC, which correlates to a tensile strength of about 157,000 psi, to values as low as 17.5 HRC near the fracture, which correlates to a tensile strength of about 104,000 psi.

Fig. 7. Hardness (HRC) readings along the length of longitudinal section removed from joint C2.

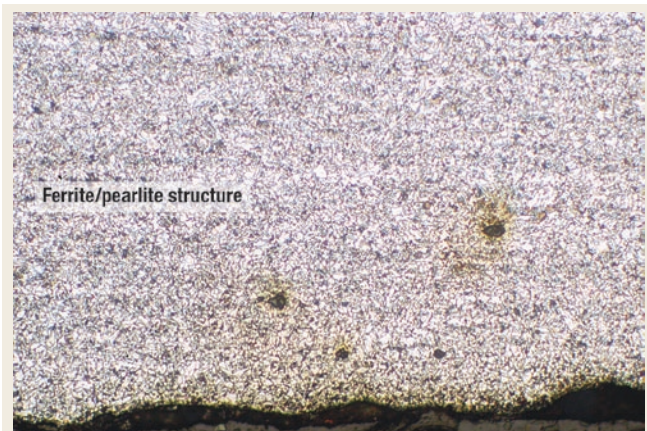
Specimens were removed from both inside and outside of the heat affected area of joint C2. Material from outside the heat affected area presented a tempered martensitic structure, which is characteristic of quenched and tempered (Q&T) steel, as required for S-135 grade drill pipe. This was the inherent drill pipe material structure. Material inside the heat affected area presented a mixed ferritic and pearlitic structure. Figures 10 and 11 present the two microstructures. Transformation of the grain structure in the heat affected area indicated that localized heating resulted in temperatures above 1,500°F (aus-

Fig. 11. Microstructure near fractured end of joint C2 (200X).

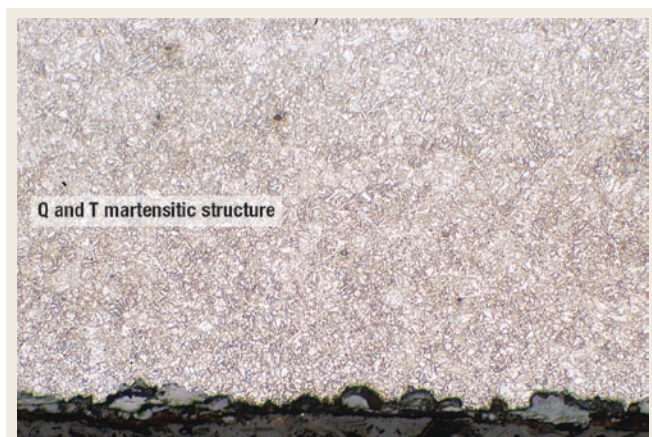
Fig. 10. Inherent microstructure of joint C2 (200X).

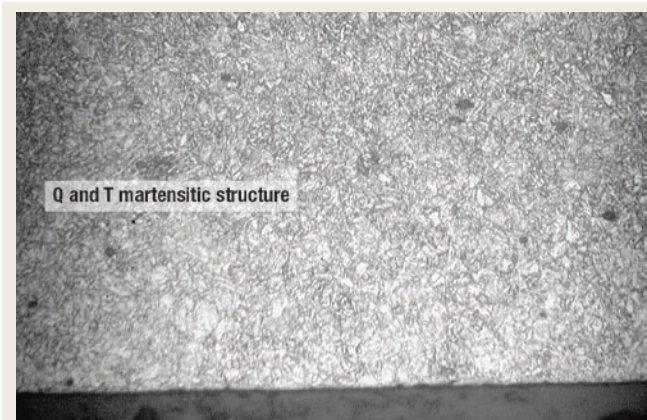
Fig. 12. Inherent microstructure of joint C1 (200X).

Specimens for microstructural examination were also removed from both inside and outside of the heat affected area of joint C1. However, unlike the change in structure observed on joint C2, both specimens removed from joint C1 presented a tempered martensitic structure. This is shown in Figs. 12 and 13. Presence of a similar structure meant that the temperatures reached in the heat affected area of joint C1 did not exceed the austenitic transformation temperature (~1,500°F). Instead the temperatures reached were closer to the typical tempering temperature for G-105 grade drill pipe material (~1,000°F).

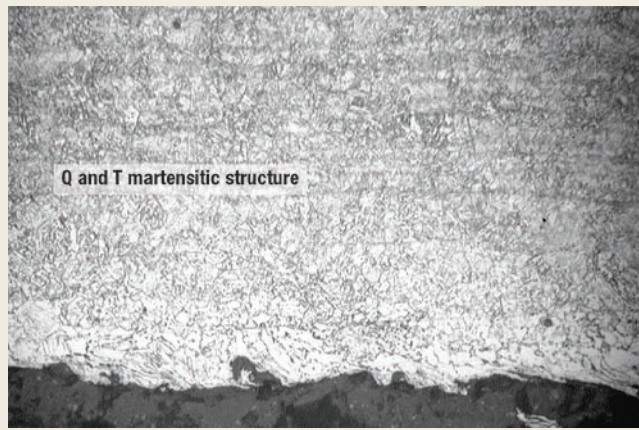
Fig. 13. Microstructure near fractured end of joint C1 (200X).
