## Supplementary Specs Key For N-80

By Samit Gokhale and Sean Ellis

HOUSTON—N-80 casing is a preferred casing grade for production casing strings. N-80 casing is usually ordered to API Specification 5CT without specifying the appropriate supplementary requirements. However, casing strings that meet the minimum strength requirements of API Specification 5CT have experienced sudden failures during normal workover and well stimulation operations.

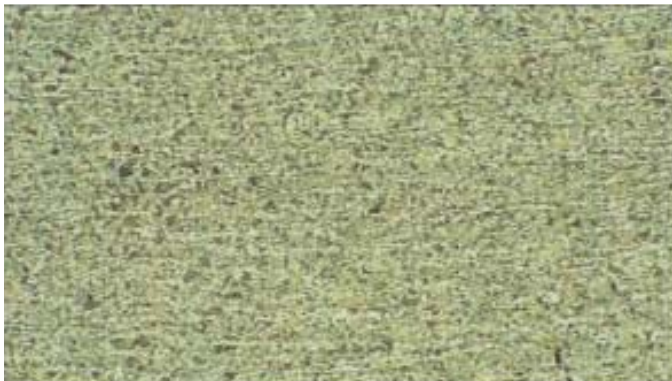
**FIGURE 2C**

**Failed Casing Joint Microstructure  
After Normalizing at 1,472° (x100)**

The re-heat treated sections presented a fine structure of ferrite and pearlite. Significant refinement in the overall grain size was observed. Unlike the coarse pearlitic structure (pearlitic grain size of 3.0) and fine ferrite structure (ferrite grain size of 13.0) of the original material, the re-heat treated structure was more uni-

After normalizing the sections from the failed casing at these temperatures, the microstructures were examined and the grain size was measured. Charpy V-notch impact tests also were performed on half-size specimens machined from the re-heat treated sections. The overall grain sizes of the original and re-heat treated sections of the failed casing were 5.5 as received, 6.8 after re-heat treating at 1,436 degrees, 7.9 after re-heat treating at 1,472 degrees, and 8.1 after re-heat treating at 1,508 degrees. The microstructures are presented in Figures 2A-2D. Table 3 presents the impact energy values of the re-heat treated sections.

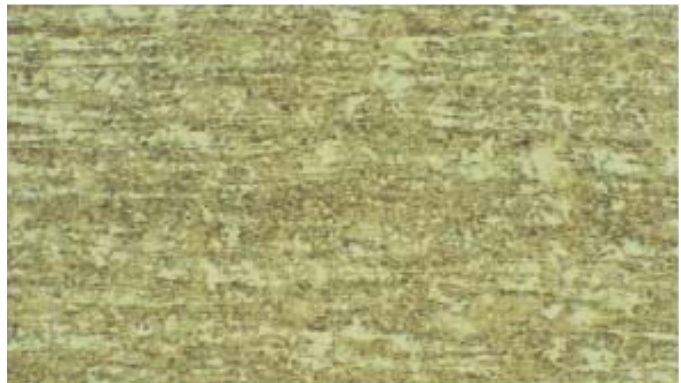
**FIGURE 2B**

**Failed Casing Joint Microstructure  
After Normalizing at 1,436° (x100)**

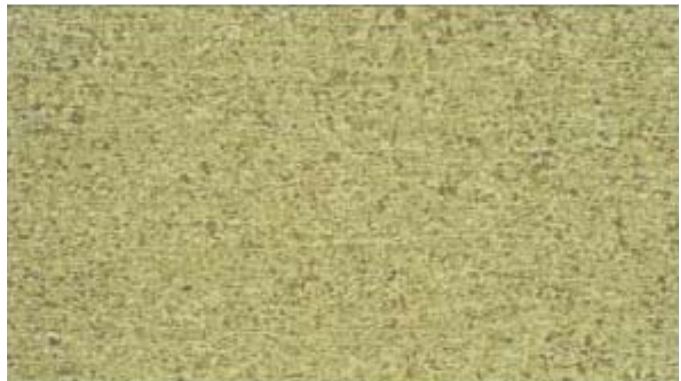
**FIGURE 2D**

**Failed Casing Joint Microstructure  
After Normalizing at 1,508° (x100)**

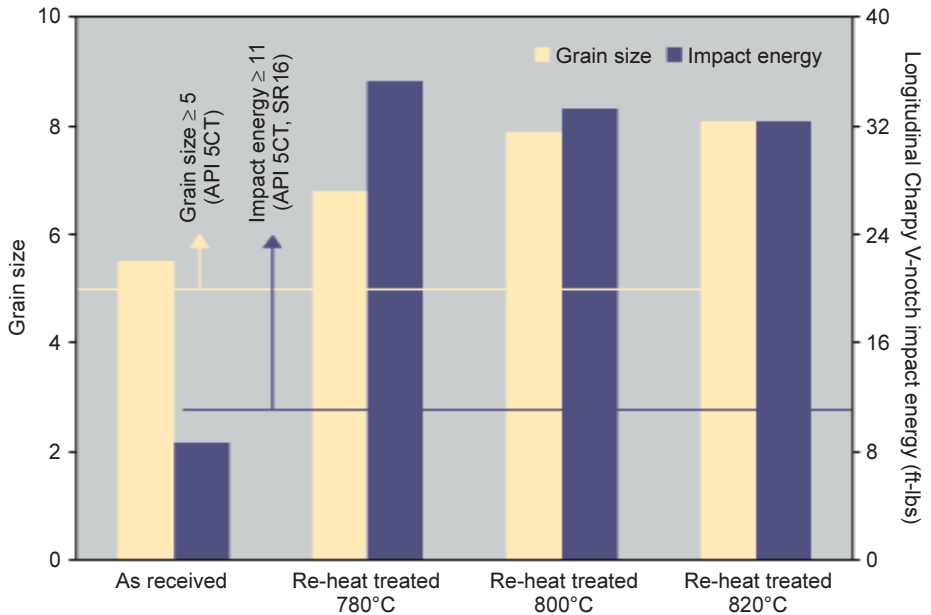
**FIGURE 3**

**Grain Size and Impact Energy Improvement (Re-Heat Treated Sections)**

Significant improvement in the impact energy values also was observed. The average impact energy of the re-heat treated sections was greater than the minimum required value specified in the sup-

plementary requirement SR16 of API Specification 5CT. The improvement in the grain size and the impact energy values is depicted in Figure 3.

toughness for each of the re-heat treated sections, as compared to the microstructure of the original material, confirmed that the failed casing was improperly heat treated, and this resulted in the poor material fracture toughness. The casing material may have been heated to a temperature less than 1,436 (780 Celsius) degrees.
