Heat-induced drill pipe failures

Rotating while packed off may cause unexpected heat-induced drill pipe tensile failures

Samit Gokhale and Sean Ellis, T H Hill Associates, Inc.; Nicholas Reynolds, SPE

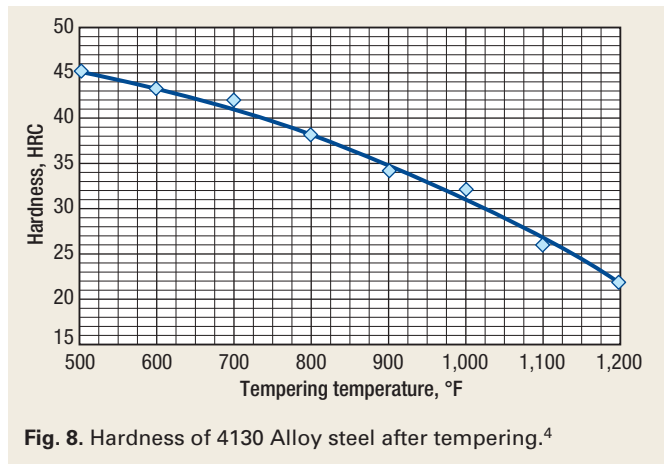
Fig. 8. Hardness of 4130 Alloy steel after tempering.⁴

“Tempering of steel is a process in which previously hardened steel is heated to a temperature below the transformation range and cooled at a suitable rate, primarily to increase ductility and toughness.”³ Tempering usually results in a decrease in hardness, tensile strength and yield strength, but an increase in ductility and toughness. Figure 8 shows the effect of tempering temperature on the hardness of 4130 alloy steel (this is the same material from which joints C1 and C2 were made).

values at the time of the failures would have been much lower. However, because there is no way of knowing what temperatures the drill pipe joints reached when rotated while packed off, the tensile strength at the time of failure is unknown.

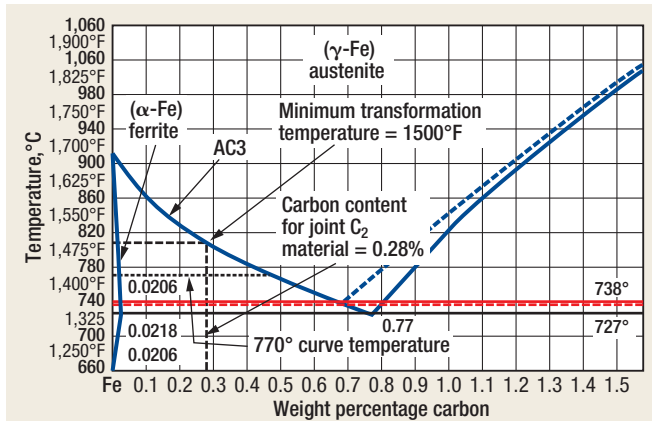
Fig. 9. Carbon-iron phase diagram.⁵

Microstructural examination. The drop in hardness in the heat affected area indicates that the drill pipe was locally heated to a temperature equal to or greater than the tempering temperature. One way to determine the approximate temperature range to which the pipe was heated is to examine the microstructure in the heat affected area and compare it with the microstructure outside the heat affected area. A change in the microstructure (from the inherent structure) in the heat affected area would mean that the temperatures reached were greater than the austenitic transformation temperature. This minimum phase transformation temperature is represented by line “AC3” on the carbon-iron phase diagram shown in Fig. 9.

Specimens were removed from both inside and outside of the heat affected area of joint C2. Material from outside the heat affected area presented a tempered martensitic structure, which is characteristic of quenched and tempered (Q&T) steel, as required for S-135 grade drill pipe. This was the inherent drill pipe material structure. Material inside the heat affected area presented a mixed ferritic and pearlitic structure. Figures 10 and 11 present the two microstructures. Transformation of the grain structure in the heat affected area indicated that localized heating resulted in temperatures above 1,500°F (aus-

tenitic transformation temperature for joint C2 material, as shown in Fig. 9).
