Program Reduces NPT In Barnett Shale

By Fred Kellow,
Jeff Everage,
Shawn Altizer
and Juan Veloz

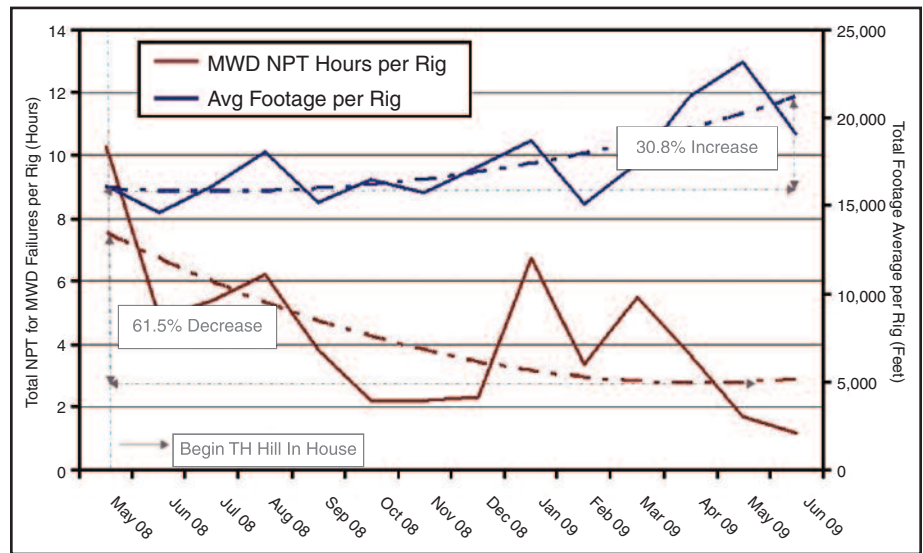
FIGURE 1
Monthly MWD NPT and Average Footage Drilled

Figure 1 shows the average number of hours of MWD tool NPT each month per rig from May 2008 to June 2009, as well as the average monthly footage drilled per rig. Over the course of the study, MWD tool NPT declined 61.5 percent, from 7.8 hours to 3.0 hours per rig each month. Likewise, average monthly footage drilled per rig increased by 30.8 percent, from 15,200 to 22,000 feet.

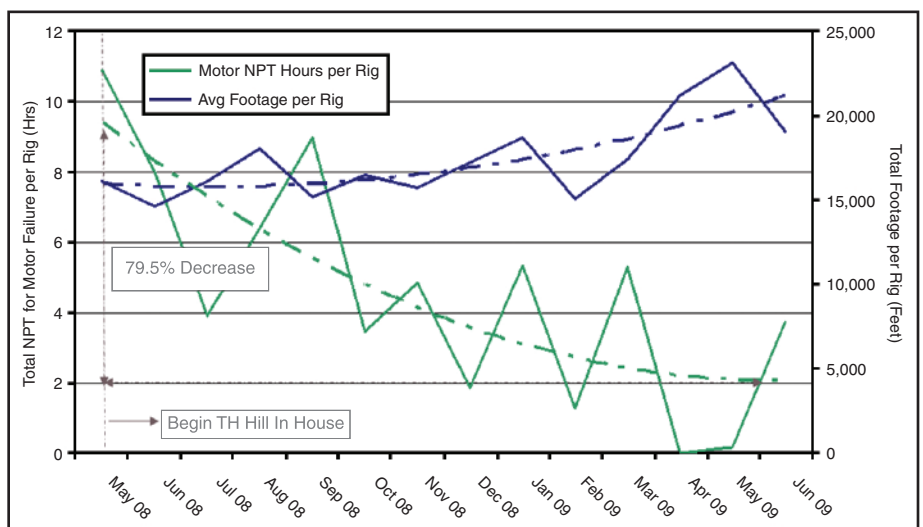
FIGURE 2
Monthly Mud Motor NPT and Average Footage Drilled

Similarly, Figure 2 shows the average number of hours of MM NPT each month per rig, as well as the average monthly footage drilled per rig over the same period. Mud motor NPT declined 79.5 percent, from 9.5 hours to 2.0 hours a month per rig.

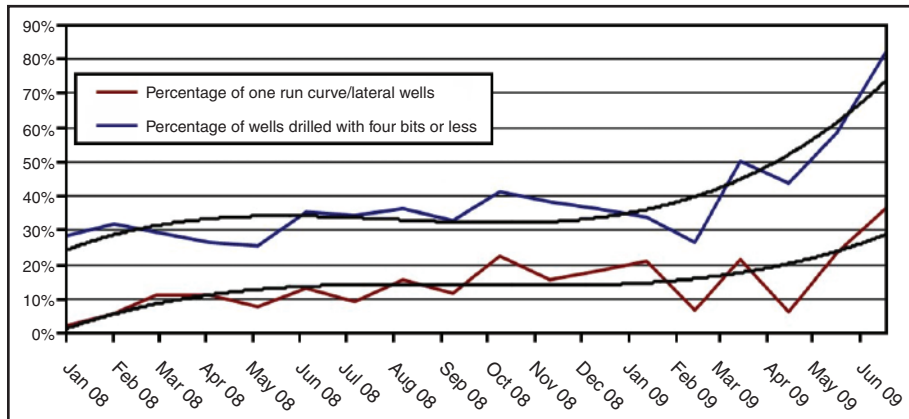
FIGURE 3
Percentage of Wells Drilled with Four or Fewer Bits

In addition, better performing MMs and more reliable MWD tools allowed the operator to drill wells with fewer bits. Figure 3 contains a data set of 749 wells. The bottom curve represents 100 wells that were drilled with three bits, using only one bit in the curve and the lateral. At the time of the study, wells drilled with one bit through the build section and lateral had increased to 30 percent.

However, it was not uncommon for Devon Energy to elect to use four bits if offset data showed historical issues in the build section, or if a longer lateral section was required to reach total depth. The top curve in Figure 3 represents all wells that were drilled with four or fewer bits. Over the course of the study, the percentage of

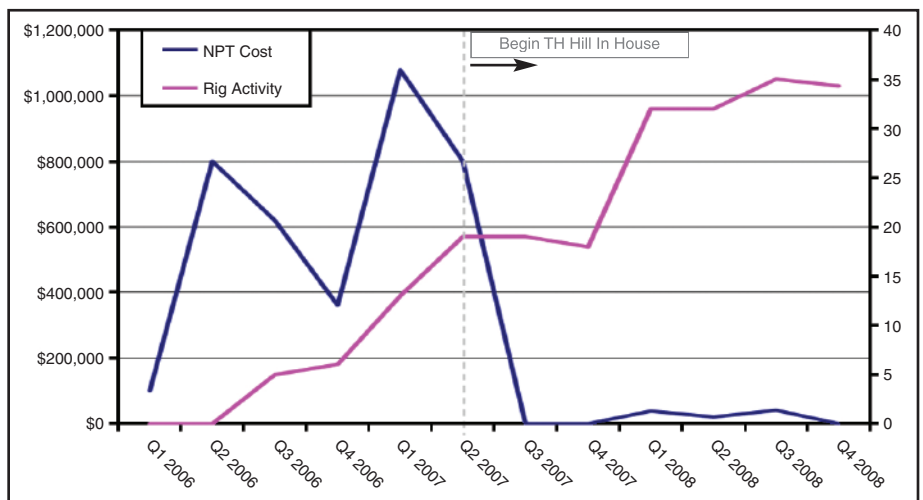
FIGURE 4
Updated Quarterly NPT Cost versus Rigs Covered By Quality Program

The original quarterly tubular NPT cost versus the rigs covered in the quality program was updated to reflect the continued success of the initial drill pipe quality program. Figure 4 plots NPT cost over the course of the implementation process. When a full-time project manager was engaged to oversee quality across the entire rig fleet in the second quarter of 2007, a drastic reduction in NPT from drill pipe and HWDP fatigue failures was realized. The NPT experienced in 2008 for drill pipe and HWDP fatigue failures remained negligible, confirming the success of the operator’s approach.
